**Flood Control Project Maintenance
Levee Inspections**
LMA District Cover Sheet
Spring 2017 Levee Inspection Results

Reclamation District No. 0001 Union Island

Levee Inspection Report By Mile - Spring 2017

Waterway	Bank	Unit Miles	Inspection Start/End	Inspector
Unit No. 01 Old River	Right	1.14	04/12/2017 04/12/2017	Maksim Khashchuk

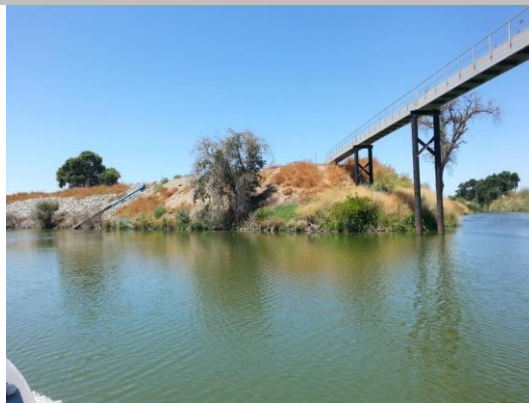
Photo 1 of 3 : SP_2017_RD0001_23_1_20170407_00001.jpg

LM Start	0.00	Rating **	M	Issue No.	1
LM End	0.00	Issue Type +	Ma	Location *	WS
Category	Supplemental			GPS Latitude/Longitude	
				Start	End
Item	DWR Erosion Survey			37.822306 °	37.822306 °
				-121.375304 °	-121.375304 °
DWR ID	DWR_RD0001_01_s_2017_1				
Comment Code					
Inspector Comment					
07/25/2016: No significant change observed.					
06/25/2015: No significant change observed.					
07/02/2014: No significant change observed.					
08/20/2013: No significant change at this site.					
08/07/2012: The erosion is at the confluence of Old River and one of its tributary. [2016 Site ID:RD0001U01RM31.4]

Upstream view of the erosion.

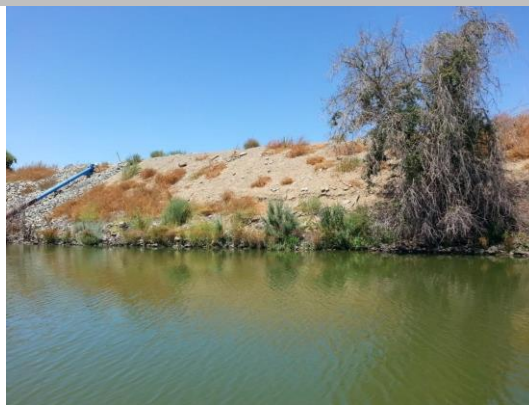
Photo 2 of 3 : SP_2017_RD0001_23_1_20170407_00002.jpg

Close view of the erosion.

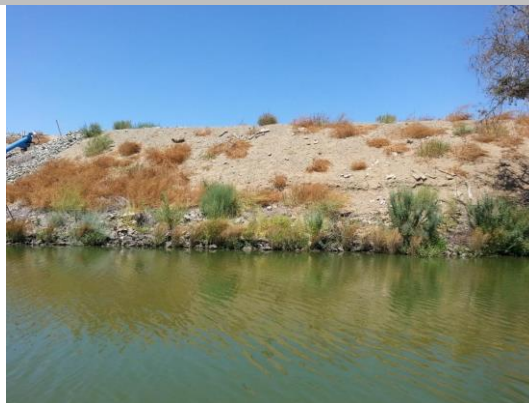
Photo 3 of 3 : SP_2017_RD0001_23_1_20170407_00003.jpg

Front view of the site. Note the large tree on site.

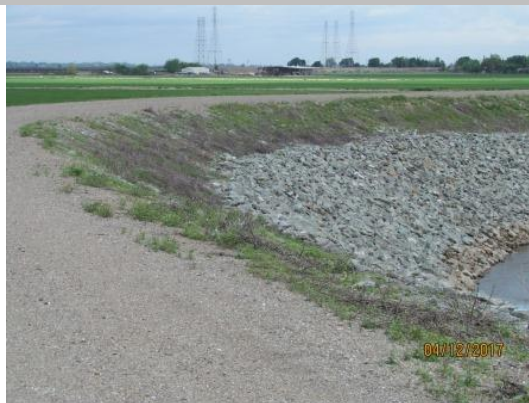
Photo 1 of 1 : SP_2017_RD0001_23_17_20170417_00016.jpg

LM Start	0.01	Rating **	A	Issue No.	17
LM End	1.02	Issue Type +	Ma	Location *	WS
Category	Earthen Levee			GPS Latitude/Longitude	
				Start	End
Item	Vegetation			37.822435 °	37.812796 °
				-121.375722 °	-121.383933 °
DWR ID	DWR_RD0001_01_s_2017_17				
Comment Code					
V1 : Control annual grass and weeds on the levee slopes and easements.					
Inspector Comment					
Acceptable vegetation control.

View of the acceptable vegetation control on the levee slope.

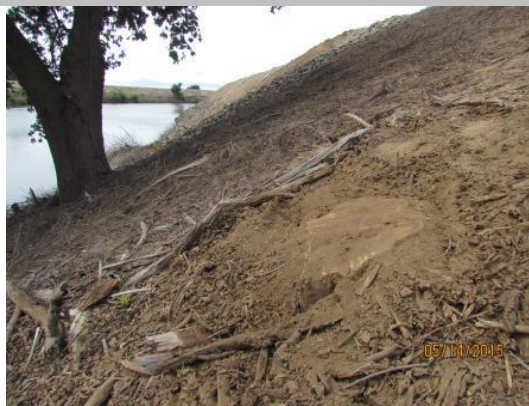
Photo 1 of 1 : SP_2017_RD0001_23_12_20170407_00010.jpg

View of the tree stump on the waterside levee slope.

LM Start	0.17	Rating **	N	Issue No.	12
LM End	0.17	Issue Type +	Ma	Location *	WS
Category	Earthen Levee			GPS Latitude/Longitude	
				Start	End
Item	Trim / Thin Trees			37.821376 °	37.821376 °
				-121.378044 °	-121.378044 °
DWR ID	DWR_RD0001_01_s_2014_12				
Comment Code					
T5 : Tree stumps.					
Inspector Comment					
Remove stump when it becomes rotted to prevent possible seepage path along the roots.

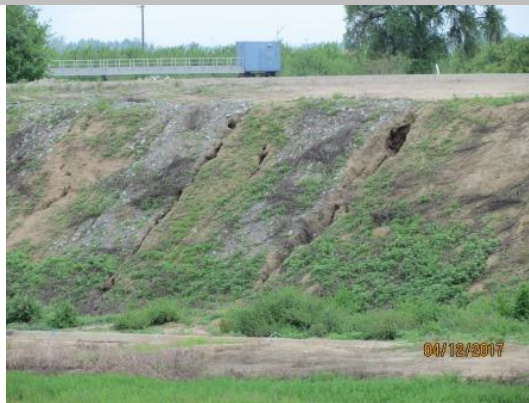
Photo 1 of 1 : SP_2017_RD0001_23_18_20170417_00017.jpg

View of the erosion on the levee slope.

LM Start	0.21	Rating **	M	Issue No.	18
LM End	0.21	Issue Type +	Ma	Location *	LS
Category	Earthen Levee			GPS Latitude/Longitude	
				Start	End
Item	Erosion / Bank Caving			37.820806 °	37.820806 °
				-121.378260 °	-121.378260 °
DWR ID	DWR_RD0001_01_s_2017_18				
Comment Code					
E2 : Schedule repair of erosion site prior to the next inspection.					
Inspector Comment

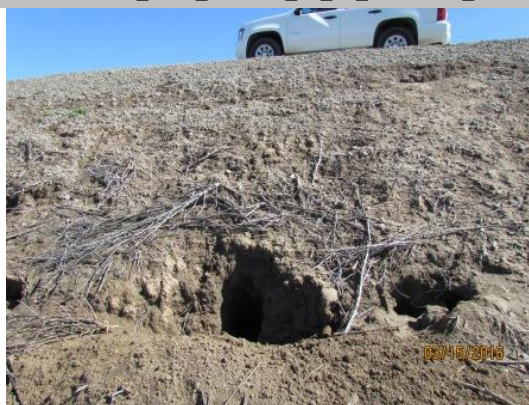
Photo 1 of 1 : SP_2017_RD0001_23_14_20170407_00011.jpg

LM Start	0.44	Rating **	U	Issue No.	14
LM End	0.44	Issue Type +	Ma	Location *	LS
Category	Earthen Levee			GPS Latitude/Longitude	
				Start	End
Item	Animal Control			37.818898 °	37.818898 °
				-121.380332 °	-121.380332 °
DWR ID	DWR_RD0001_01_s_2016_14				
Comment Code					
A1 : Exterminate rodents and backfill and compact or grout burrows.					
Inspector Comment					
Active rodent den a size of a coyote or fox.

View of the large rodent hole on the landside levee slope.

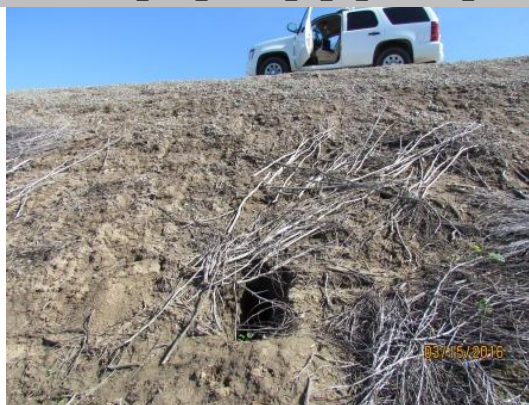
Photo 1 of 1 : SP_2017_RD0001_23_10_20170407_00008.jpg

View of the large rodent hole on the landside levee slope.

LM Start	0.45	Rating **	U	Issue No.	10
LM End	0.45	Issue Type +	Ma	Location *	LS
Category	Earthen Levee			GPS Latitude/Longitude	
				Start	End
Item	Animal Control			37.818753 °	37.818753 °
				-121.380249 °	-121.380249 °
DWR ID	DWR_RD0001_01_s_2016_10				
Comment Code					
A3 : No rodents visible, but rodent burrows visible; need to backfill and compact or grout burrows.					
Inspector Comment					
Backfill and compact levee slope with acceptable levee fill.

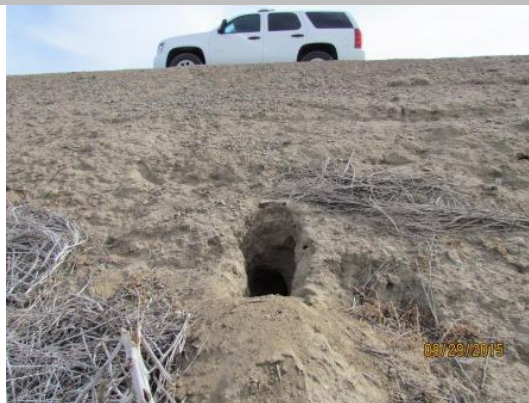
Photo 1 of 1 : SP_2017_RD0001_23_4_20170407_00005.jpg

LM Start	0.76	Rating **	U	Issue No.	4
LM End	0.76	Issue Type +	Ma	Location *	LS
Category	Earthen Levee			GPS Latitude/Longitude	
				Start	End
Item	Animal Control			37.815881 °	37.815881 °
				-121.382704 °	-121.382704 °
DWR ID	DWR_RD0001_01_f_2015_4				
Comment Code					
A1 : Exterminate rodents and backfill and compact or grout burrows.					
Inspector Comment					
Large burrow in the landside levee slope. Possible fox den. Cobwebs are visible in the hole. Fall 2016.

View of a large rodent hole on the landside levee slope.

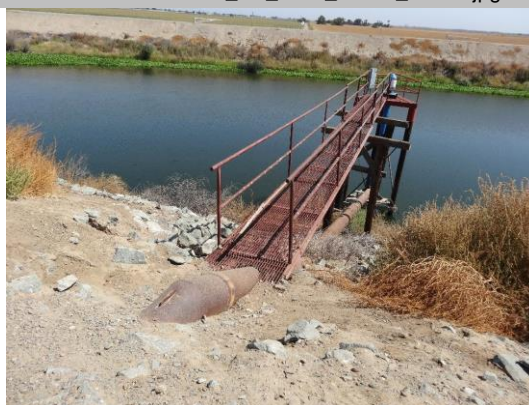
Photo 1 of 3 : UCIP_SP_2017_41600_36004.jpg

LM Start	0.85	Rating **	M	Issue No.	19
LM End	0.85	Issue Type +	En	Location *	LS
Category	Supplemental			GPS Latitude/Longitude	
				Start	End
Item	DWR UCIP Field Study			37.814601 °	37.814601 °
				-121.382509 °	-121.382509 °
DWR ID					
Comment Code					
Inspector Comment					
FS_ID:41600 DS_ID:22691 EP_NO: N/A Repair Type: Non-Urgent Crossing Status: Found UCIP Comments: - 2" electric conduit on WS- pipe exposed on both sides.- power pole on LS. - erosion on WS hinge near walkway. FIELD_STRUCT_DESC: 14-inch pipe and 2-inch electric conduit through the levee, 6.0 feet below the crown, pump on pile structure in the stream, air valve on the landward shoulder, 30-inch concrete standpipe on the landward toe. O&M Manual LSJR 8, 1968 FS Date: 9/12/2013

WS view: exposed pipe, walkway, and pump on pile structure. Soil erosion on levee hinge near walkway.

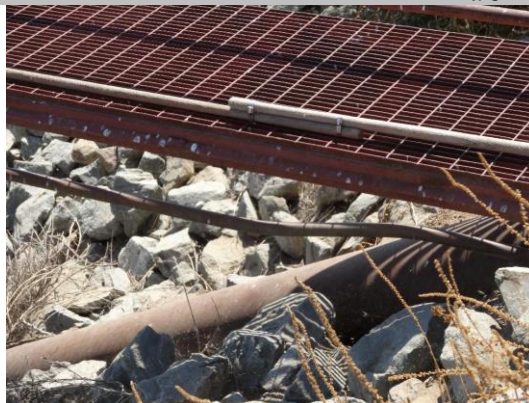
Photo 2 of 3 : UCIP_SP_2017_41600_36003.jpg

WS view: exposed pipe, walkway, and electric conduit under walkway.
Rock revetment on lower levee slope.

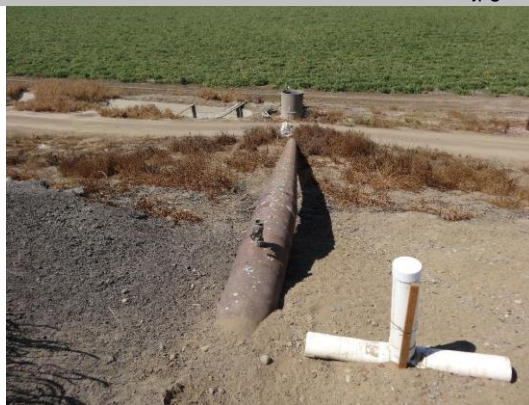
Photo 3 of 3 : UCIP_SP_2017_41600_36002.jpg

LS view: exposed steel pipe on levee slope and concrete standpipe on levee toe.

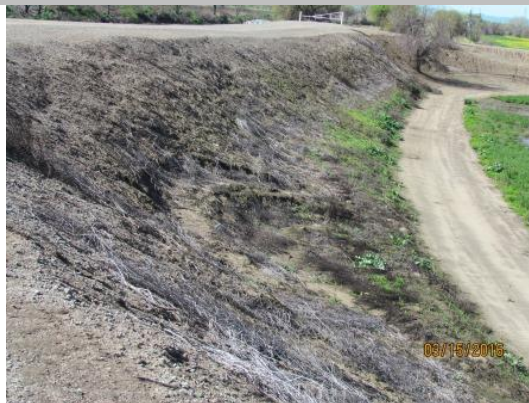
Photo 1 of 1 : SP_2017_RD0001_23_3_20170407_00004.jpg

View of the landside slope damaged by farm equipment.

LM Start	1.08	Rating **	M	Issue No.	3
LM End	1.08	Issue Type +	Ma	Location *	LS
Category	Earthen Levee			GPS Latitude/Longitude	
				Start	End
Item	Slope Stability			37.812023 °	37.812023 °
				-121.383961 °	-121.383961 °
DWR ID	DWR_RD0001_01_s_2016_3				
Comment Code					
S3 : Repair the levee slope damaged by vehicle traffic and prevent access where possible.					
Inspector Comment					
Repair slope damaged by vehicle by placing and compacting acceptable levee material.
